Saturn Pit Stop Diagnosis, Repair and Using Resources

by Mike Van Dyke

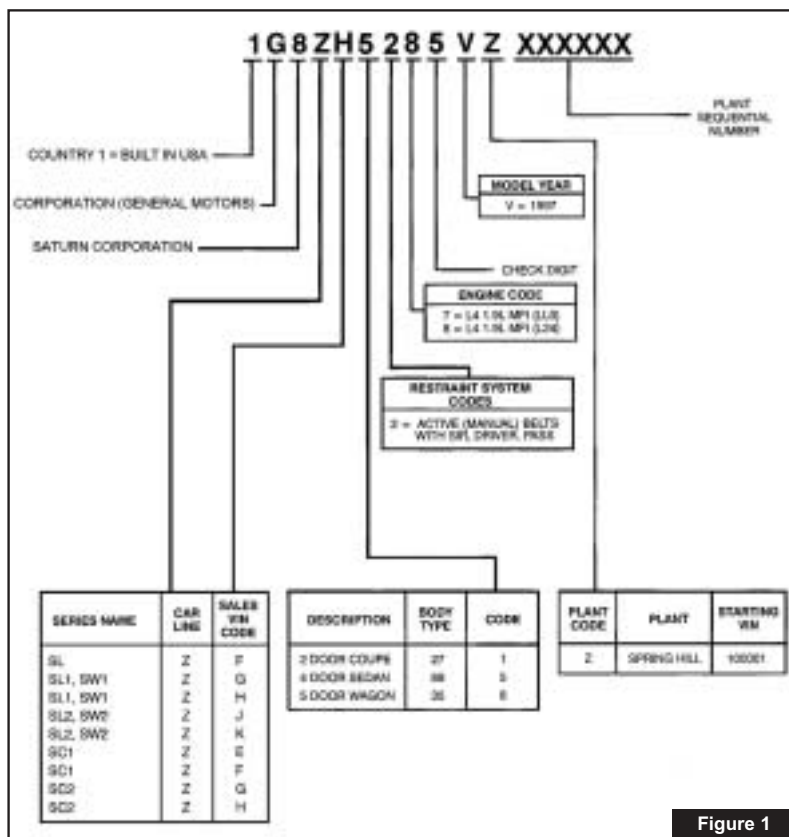
Figure 1

The 5th VIN character was H, making it an SL1 model. The 8th character was 8, so the engine was an RPO (Regular Production Option) code L24 (single overhead camshaft). The 10th VIN character was V, so the model year was 1997 (figure 1).

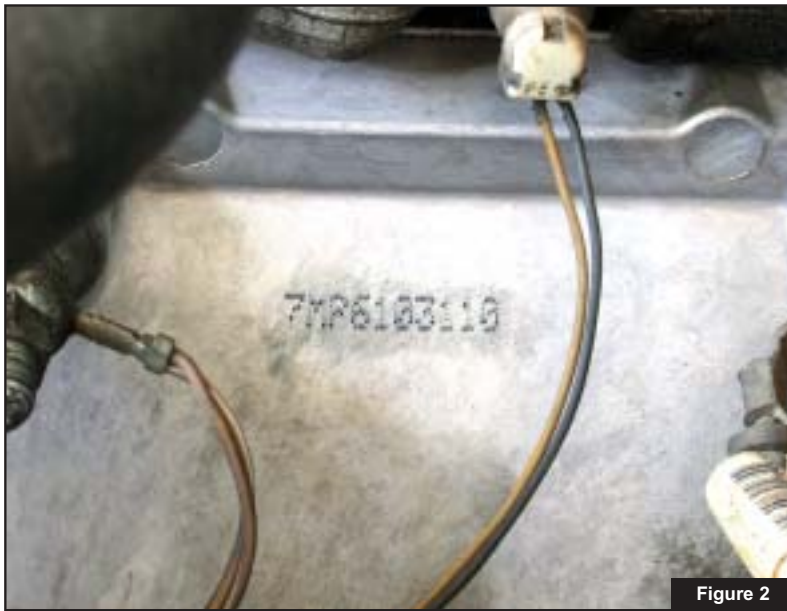
Figure 2

The transaxle model code is stamped on the top of the transaxle case, between the two top bellhousing bolts (figure 2). Just to make sure there wasn't any monkey business going on here either, we checked the transmission model code to make sure it matched the vehicle. The first digit was a 7, making it a 1997 transaxle; the 2nd,

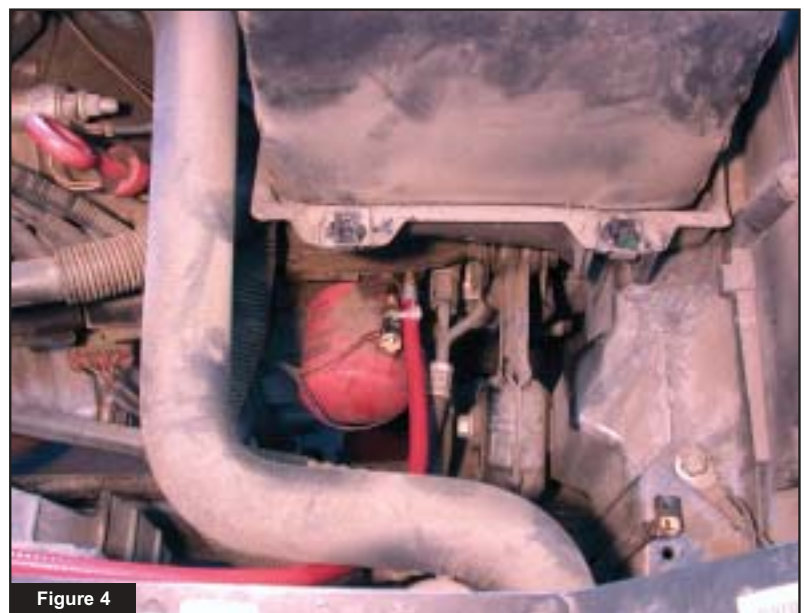
Figure 4

At this point I decided to do a line pressure test, as reverse problems with Saturn transaxles are often the result of low line pressure rise or poor line pressure control. The line pressure tap is located at the front of the unit, next to the spin-on transmission filter. To attach your gauge, remove the air filter box, then remove the transmission fluid temperature sensor and screw your gauge fitting into the temperature sensor hole (figure 4).

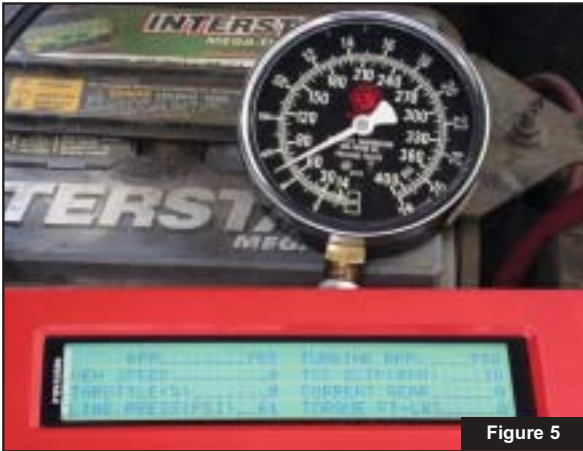
Figure 5

Saturns let you control line pressure with a scan tool, but for a quick test I watched the commanded line pressure through the scan data and compared it to the actual pressure on the gauge (figure 5). The actual line pressure was within range when compared to the commanded pressure, but during the 2nd gear command, the computer would command maximum line pressure (222 PSI) at any throttle position. This meant the computer recognized a problem with 2nd gear and was trying to compensate. This narrowed the problem down to three possibilities:

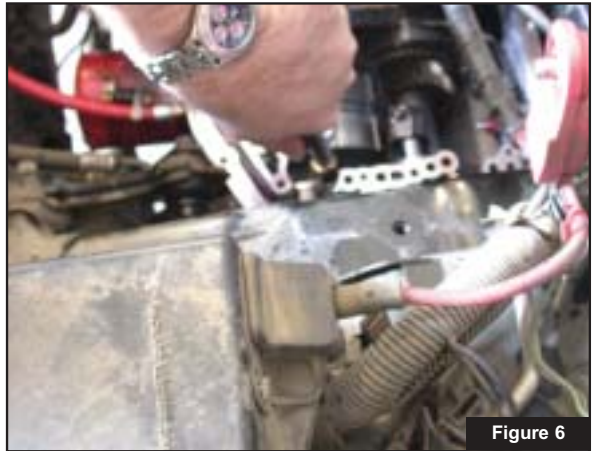
Figure 6

At this point we knew there was an internal problem in the transaxle, so I looked up the case passage ID in the ATRA 2000 seminar manual (available through ATRA Online). 10 minutes later I had the valve body off and was air testing the 2nd clutch circuit through the case (figure 6). Major leak. It wouldn't hold pressure, and there was a lot of clearance in the 2nd clutch. The 2nd clutch clearance specification is 0.060" - 0.086". We measured over 0.100". Time to pull the unit and assess the damage.

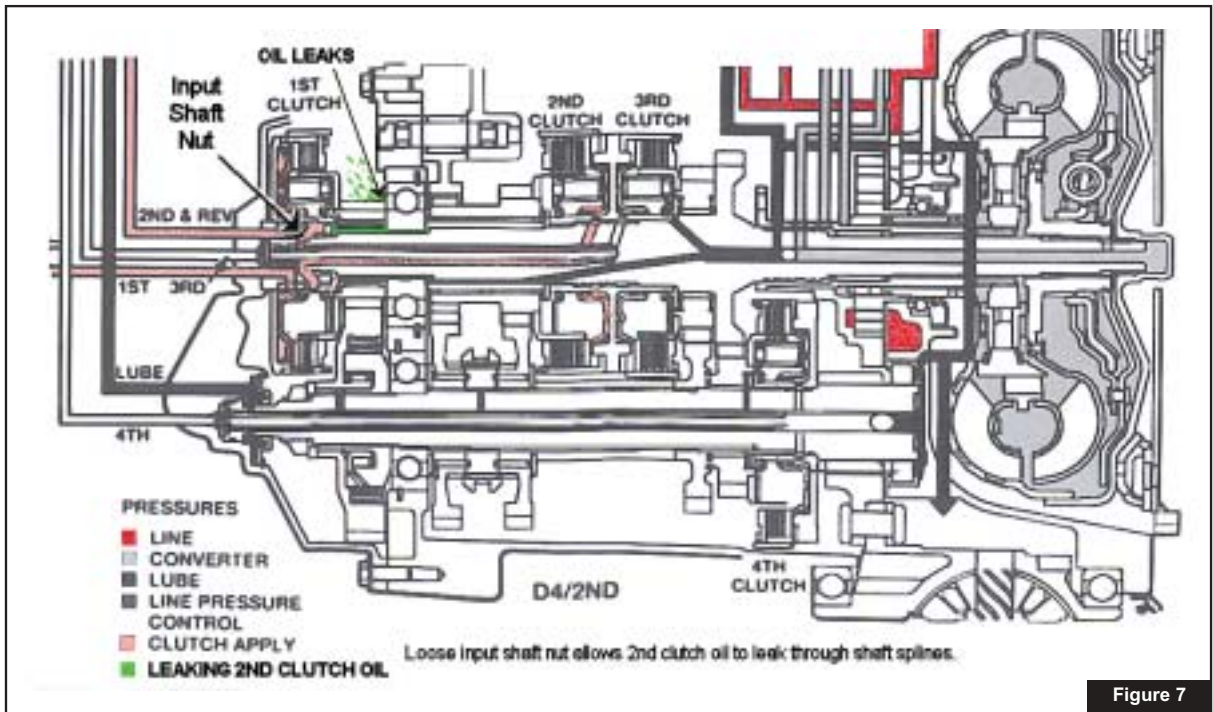
Figure 7

The cause of failure was the input shaft nut had become loose. When the input shaft nut is loose, it allows 2nd clutch oil to leak around the nut and exhaust through the 1st clutch drum splines (figure 7, see page 10). The 2nd clutches were worn, and the plastic cage was coming apart on the input shaft 2nd gear bearing. That was the extent of the geartrain damage. New clutch plates restored the 2nd clutch clearance to 0.075”.

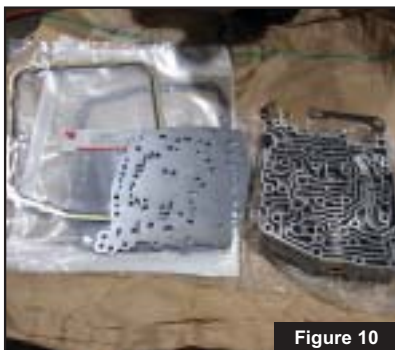
Figure 10

We disassembled and inspected the valve body, paying extra attention to the pressure regulator bore. This is a common area for wear on these valve bodies, and with 132,000 miles it was no surprise that the pressure regulator bore was worn. I could see the valve move side to side in the bore when I wiggled it with two scribes (figure 8). There was also wear evident on the valve: The anodized coating was worn off the edge of one of the valve lands (figure 9). This anodized coating is much harder than the valve bore it rides in, so if the anodizing shows signs of wear, more than likely the valve bore is severely worn. We installed a Saturn valve body service kit (P/N 21005813), which includes the upper valve body section, separator plate, gaskets, and both styles of top pan gasket (figure 10).

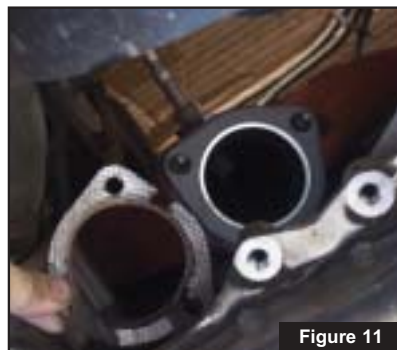
Figure 11

The exhaust flange gasket was in bad shape, so we replaced it (figure 11). The leaking water pump was also very accessible with the frame down (figure 12), so we replaced that, too (literally a 20-minute job while the transaxle is out).
