# 4L30E: 4th Accumulator Problems And More...

## 4L30E: 4th Accumulator Problems

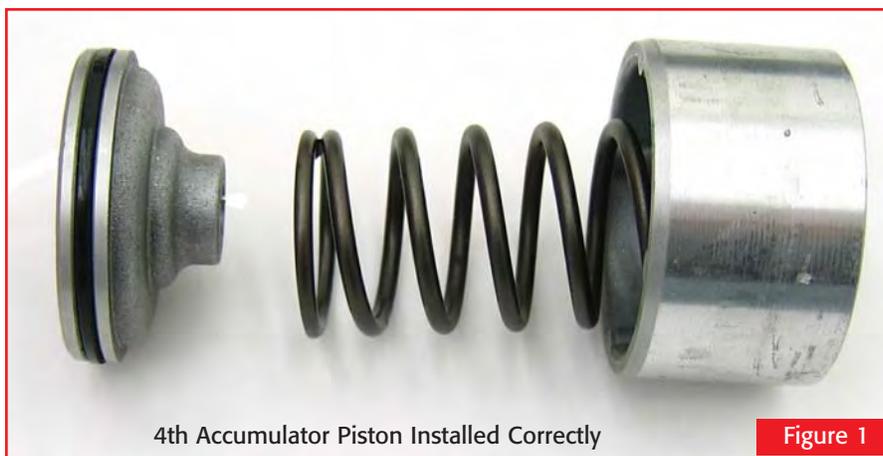
Figure 1

The 4th accumulator piston will fit into the bore either way; only one way is correct (figure 1). The raised step in the center of the accumulator piston must face toward the cover. If the accumulator piston faces the wrong way (figure 2), it will travel too far in the bore. When this happens, the seal pops out of the bore, and then gets cut on the way back in.

4th Accumulator Piston Installed Correctly

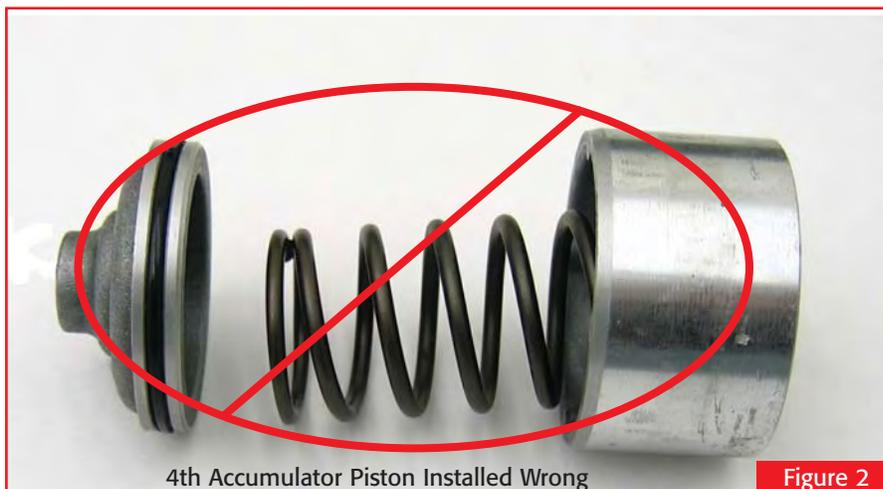
Figure 2

*My name is Bob, and I'm from Thousand Oaks, CA. I have a 91 Isuzu Trooper with a 4L30E that keeps coming back with the overdrive clutches burned. Each time it comes back, the 4th accumulator piston seal is cut. Is there a problem with the seals or do I have a bore problem?*

4th Accumulator Piston Installed Wrong

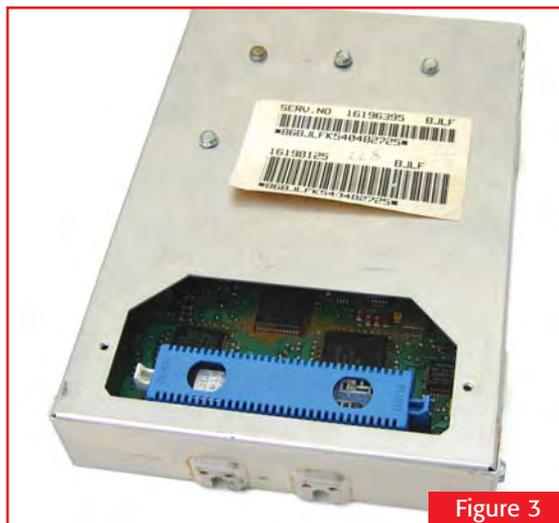
Figure 3

Hey Brad, thanks for writing. Someone has probably change the computer or the EPROM in the past (figure 3). If they installed an EPROM that was designed for a vehicle that used a PWM solenoid, it will look for the feedback voltage on the PWM circuit. On many of these early computers, the only difference is the EPROM. So, if it has the wrong EPROM, many times the only problem you'll experience is a code 83. Go to the GM dealer and order a new EPROM using the vehicle's VIN number.

If they installed an EPROM that was designed for a vehicle that used a PWM solenoid, it will look for the feedback voltage on the PWM circuit.

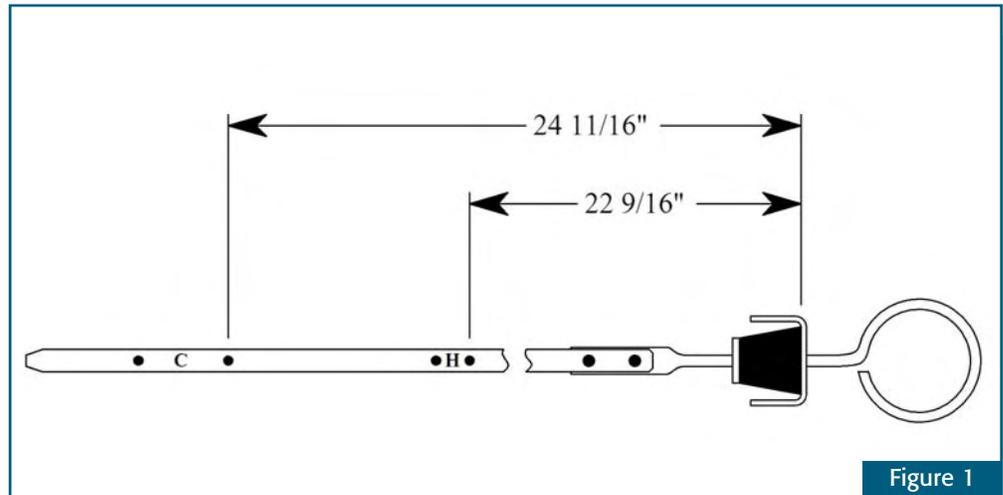
Figure 1

**C**ertain 2005-2006 Chevrolet W4500/W5500 Crewcab, GMC W4500/W5500 Crewcab and Isuzu NPR-HD/NQR Crewcab vehicles equipped with a 4HK1T diesel engine and Aisin automatic transmission may have the wrong transmission dipstick. If you adjust the ATF level based on this dipstick, you'll overfill the transmission.

To determine whether the vehicle you're working on has the wrong transmission dipstick, compare the measurements to the correct one shown (figure 1). If they don't match, order the correct dipstick GM P/N 98020252 or Isuzu P/N 8-98020252-0.
