DODGE Pickup Vibration

Traced to Worn Front Axle Bushing

In this first issue of *Fixes from the Trenches*, we're going to look at a 1999 Dodge R1500 4x4 truck with a vibration from its four wheel drive system. This article was submitted by Mark Piechowski at Berkshire Transmissions in North Adams, Massachusetts and is in his own words.

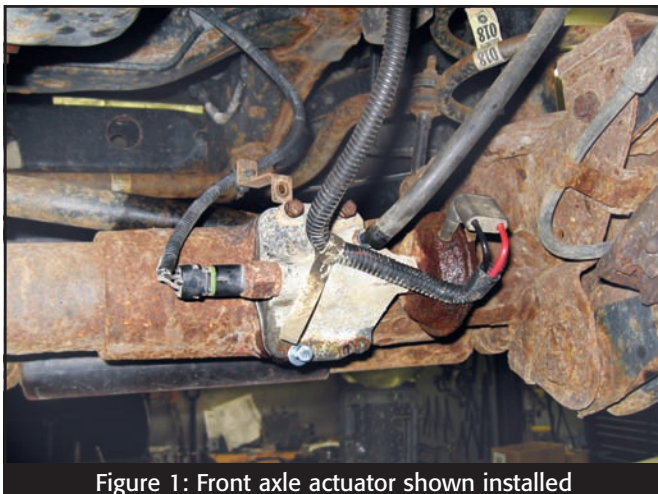
Figure 1: Front axle actuator shown installed

to the vacuum actuator and ran them into the cab. I drove the truck while my helper used a handheld vacuum pump to pull vacuum on the hoses, one at a time. We finally had control over the vibration: It was in the front axle, and it had something to do with the actuator. We went back to the shop, lifted the truck, and pulled the axle actuator.

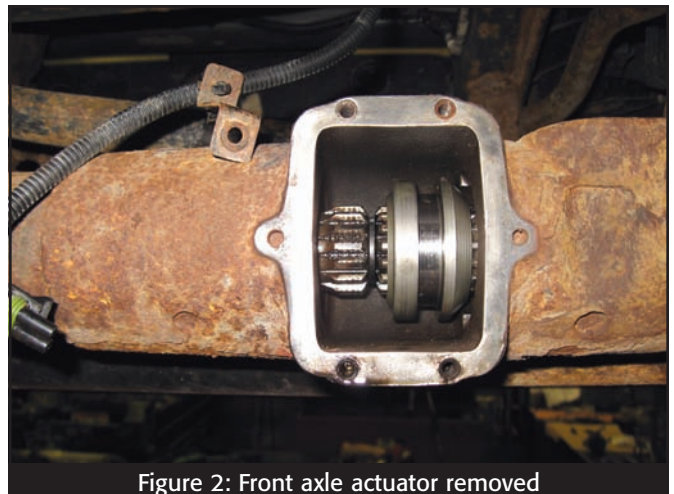
Figure 2: Front axle actuator removed

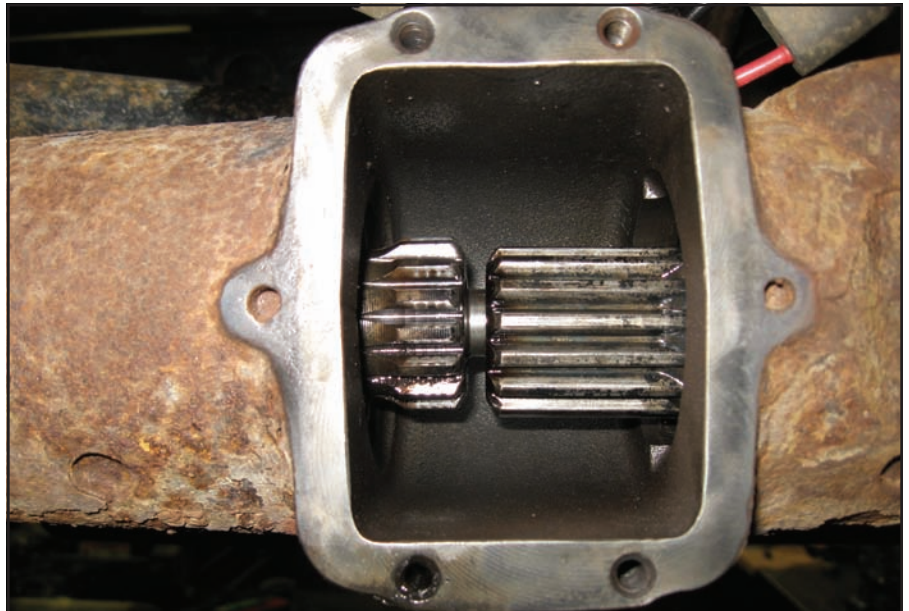
Figure 3: Notice axle bushing worn or missing

Here's what we found: The intermediate shaft has a stub that fits into a plastic bushing in a pilot hole in the passenger side axle. The stub and pilot hole are the support for the passenger

side axle shaft. The bushing for the stub was almost completely wiped out, allowing the axle shaft to flop around on the stub when the transfer case was set for 2WD. When shifted into 4WD, the sliding coupler would connect both shafts, providing support for the flopping axle shaft.

We installed the new bushing, cleaned everything up, reassembled the axle, and went on a road test. This time the vibration was gone.

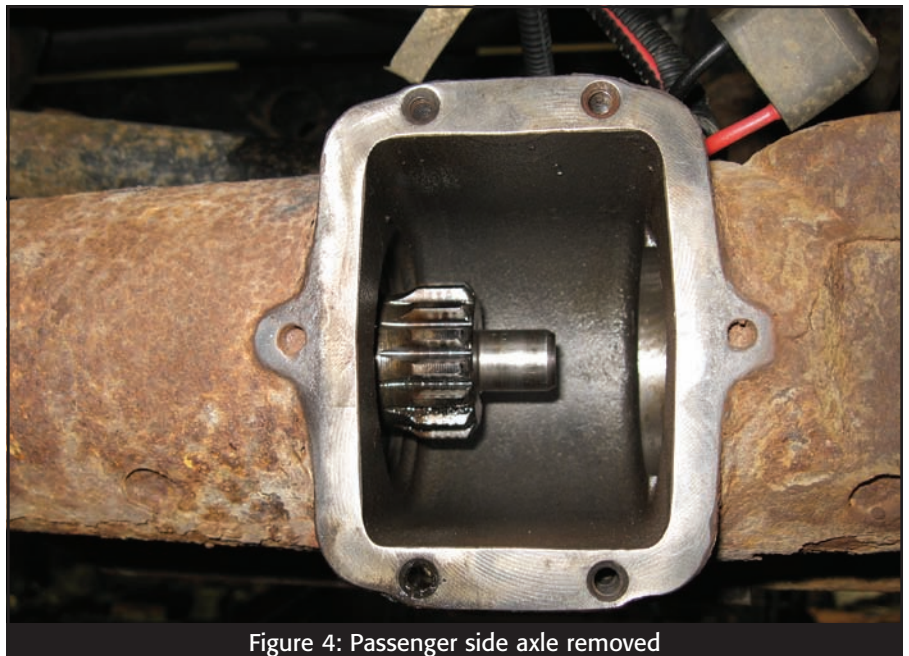
Figure 4: Passenger side axle removed

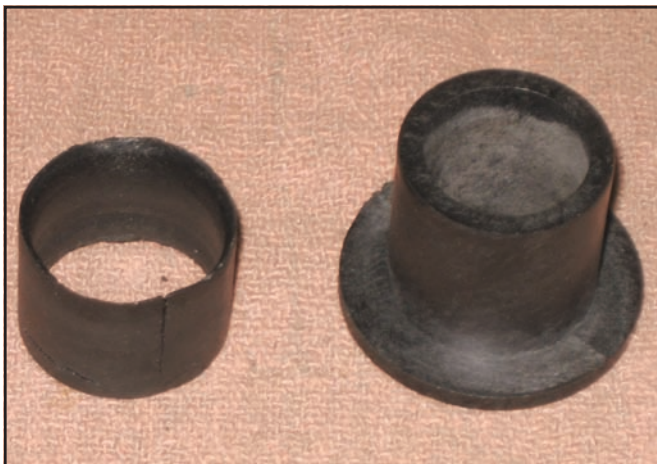
Figure 5: Compare worn bushing and new bushing

The bushing part number is Mopar 05252686 and the seal just to the right of the slide coupler is 04506005.

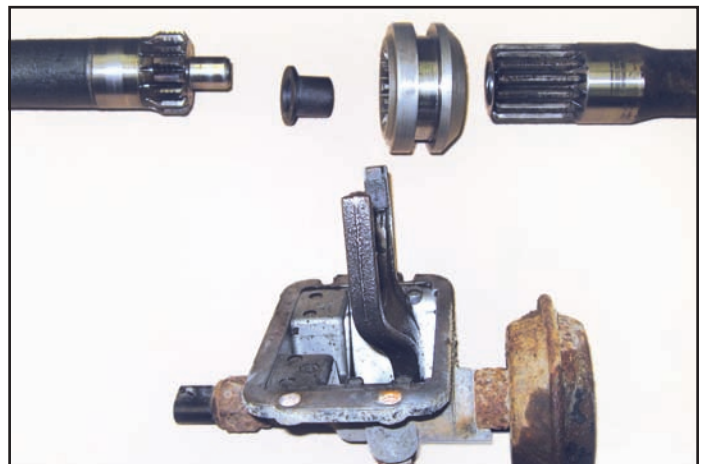
Figure 6: Breakdown of axle shafts, bushing, shift collar and actuator
