## **Doctor Doctor**, It Hurts When I Shift...

## **48RE Torque Converters:**

An Update for Longer Life

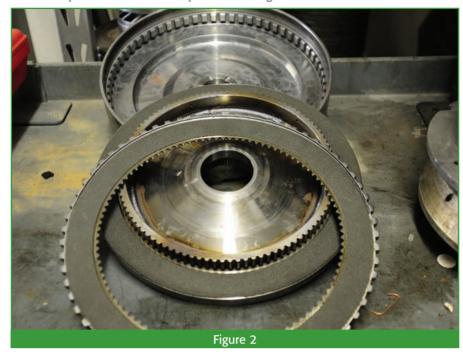
This internal converter pressure, in the original 42 through 47RE converters (figure 1), could be compromised with a leak between the converter hub and stator support assembly, allowing oil to be used/recycled through the pump gears. This leak reduced the pressure that was holding the clutch lining against the cover. This can, and often does, create a slip in the clutch lining, which eventually overheats and burns up the clutch.

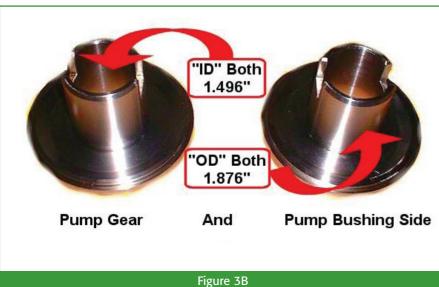
To do this, the torque converter hub was redesigned (where), eliminating the lower step on the inside ID of the hub (figures 3a and 3b), allowing for a new seal ring on the stator support. This newer design helps keep pressure inside the torque converter when it goes into lockup.
