Saturn Pit Stop Diagnosis, Repair and Using Resources

by Mike Van Dyke

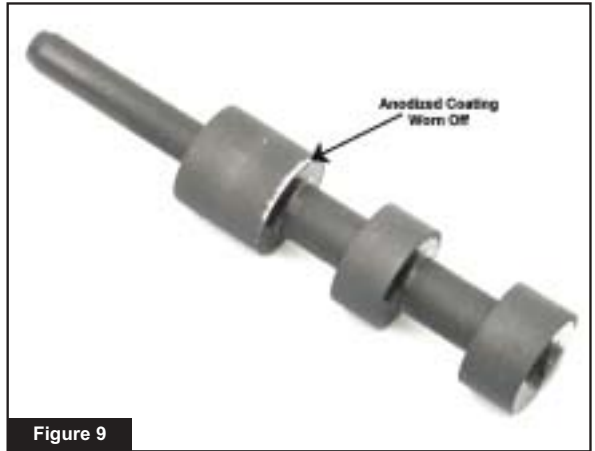
Figure 9

We disassembled and inspected the valve body, paying extra attention to the pressure regulator bore. This is a common area for wear on these valve bodies, and with 132,000 miles it was no surprise that the pressure regulator bore was worn. I could see the valve move side to side in the bore when I wiggled it with two scribes (figure 8). There was also wear evident on the valve: The anodized coating was worn off the edge of one of the valve lands (figure 9). This anodized coating is much harder than the valve bore it rides in, so if the anodizing shows signs of wear, more than likely the valve bore is severely worn. We installed a Saturn valve body service kit (P/N 21005813), which includes the upper valve body section, separator plate, gaskets, and both styles of top pan gasket (figure 10).
